# Metallurgical Evaluation of Type 304 Stainless Steel Exposed to Woodburning Stove Flue Gases

John H. Smith

January 1985

Issued February 1985 Final Report

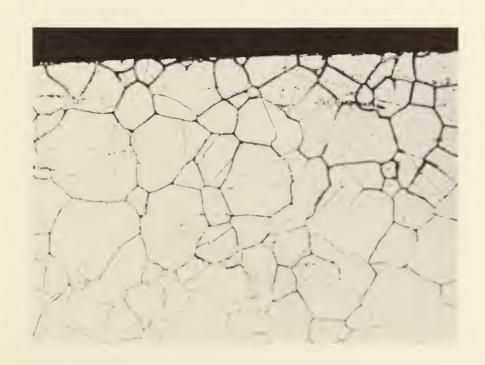
Fig. 5

micrograph (Figure 5) will be compared with similar micrographs taken after exposure of the specimens to the wood burning stove environment. No changes in the microstructure, other than the carbide precipitation at the grain boundaries, were found after the sensitization heat treatment (for example, compare Figure 1 and 4).

Edge of Double Walled Material 500X After Sensitization

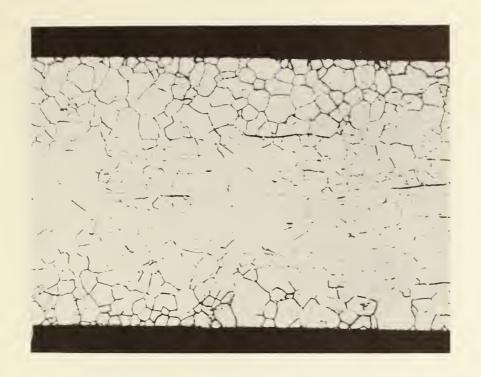
Fig. 6

As shown in Figure 6, samples taken from triple walled chimney sections showed evidence of extreme sensitization after the heat treatment at 1000° F for 100 hours in the furnace. The degree of sensitization in this material was more extreme at the surface of the specimen than of the mid-thickness of the specimen as shown in Figure 7. Complete sensitization was also observed in the test coupons that were heated in the wood burning stove chimney for 100 hours at 1000° F, as shown in Figure 8. The surface of the test coupons were only slightly roughened and no grain boundary attack was observed after the furnace heat treatment, as shown in Figure 9. The carbide precipitation due to sensitization was the only microstructural change observed in the material from the triple walled chimney sections after the heat treatment.

Triple Walled Material After Sensization 500X

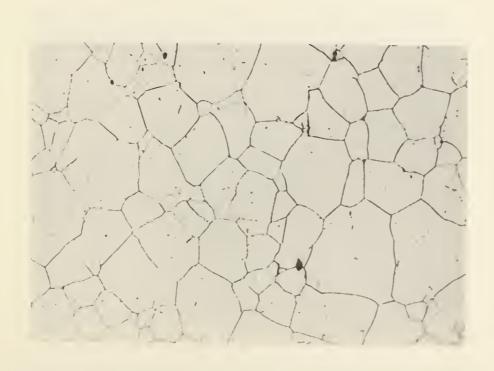
Fig. 7

Through Thickness Section of Triple Walled 200X Material After Sensitization

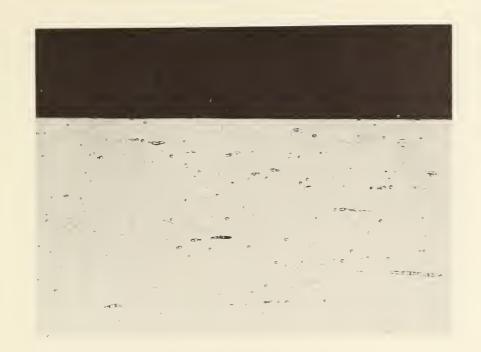
The type 321 (stabilized) stainless steel test coupons were exposed to the wood burning stove environment for a period up to 4 months after first being heat treated through the cycle that was used to sensitize the 304 stainless steel. As shown in Figure 16, no microstructural changes were observed in the type 321 stainless steel as a result of the exposure cycle. The only evidence of surface degradation or attack was limited to a depth of less than one grain diameter (0.0006 in.), as shown in Figure 16.

Type 321 Stainless Steel After Exposure 500X Fig. 16

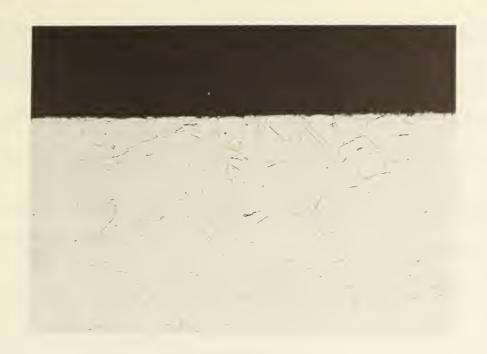
Additional samples were taken from each of the five sections from each chimney and examined by optical metallography to determine the extent of any microstructural changes and any corrosive attack during normal operation of the chimneys. Figure 18 shows the typical microstructure from the chimney sections. These chimney sections show a microstructure typical of annealed type 304 consisting of equiaxed grains of austenite containing annealing twins. No significant corrosive attack was found on the surface of the specimens. This examination did not show any significant microstructural changes as a result of the operation of the chimneys.

Edge of Type 304 Chimney Section from Field 500X Fig. 18

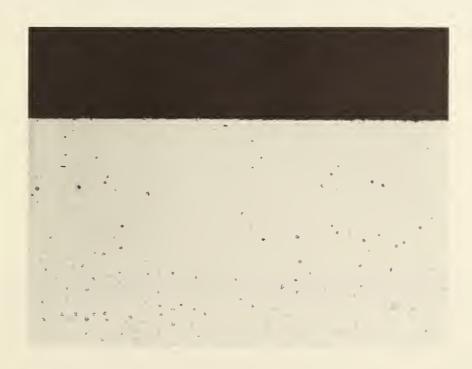
Fig. 19

The two chimneys, one double walled design and one triple walled design, which were used in the CPSC laboratory for exposure of test coupons for 3 and 6 month tests were examined metallographically. The two sections of each chimney nearest the wood burning stove were obtained for evaluation. Specimens from the inner liner of the chimney sections were examined for evidence of sensitization due to the temperature cycle used in the exposure tests. As shown in Figure 19, no evidence of sensitization was found. This indicates that normal wood stove operating cycles will not cause sensitization of the

Type 304 Chimney from Lab Tests 500X Showing Carbides
